# National Transportation Safety Board

## Marine Accident Brief

### Sinking of Fishing Vessel *Allison C*

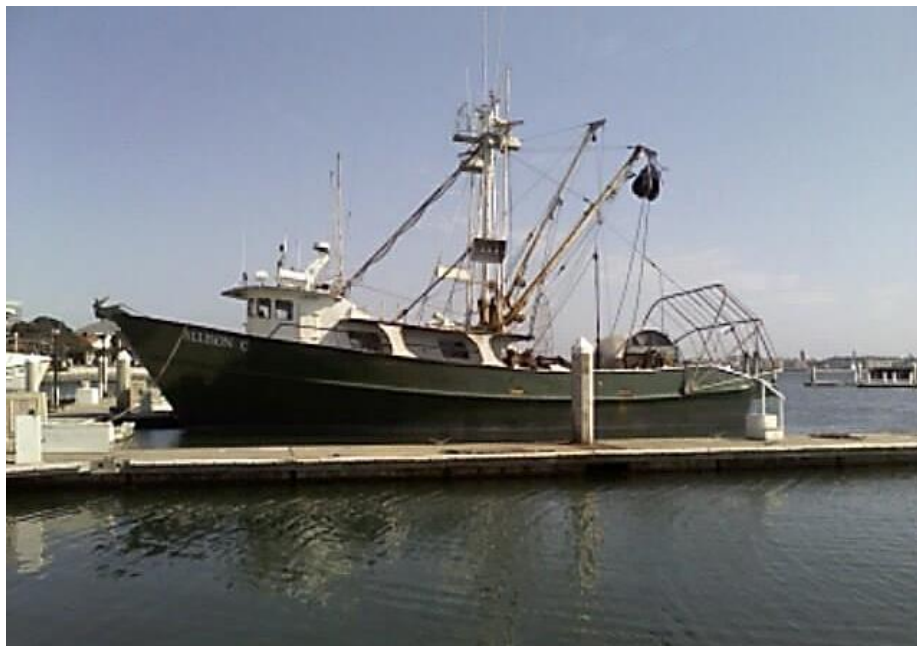
The *Allison C* before the accident. (Photo provided by John S. Bateman)

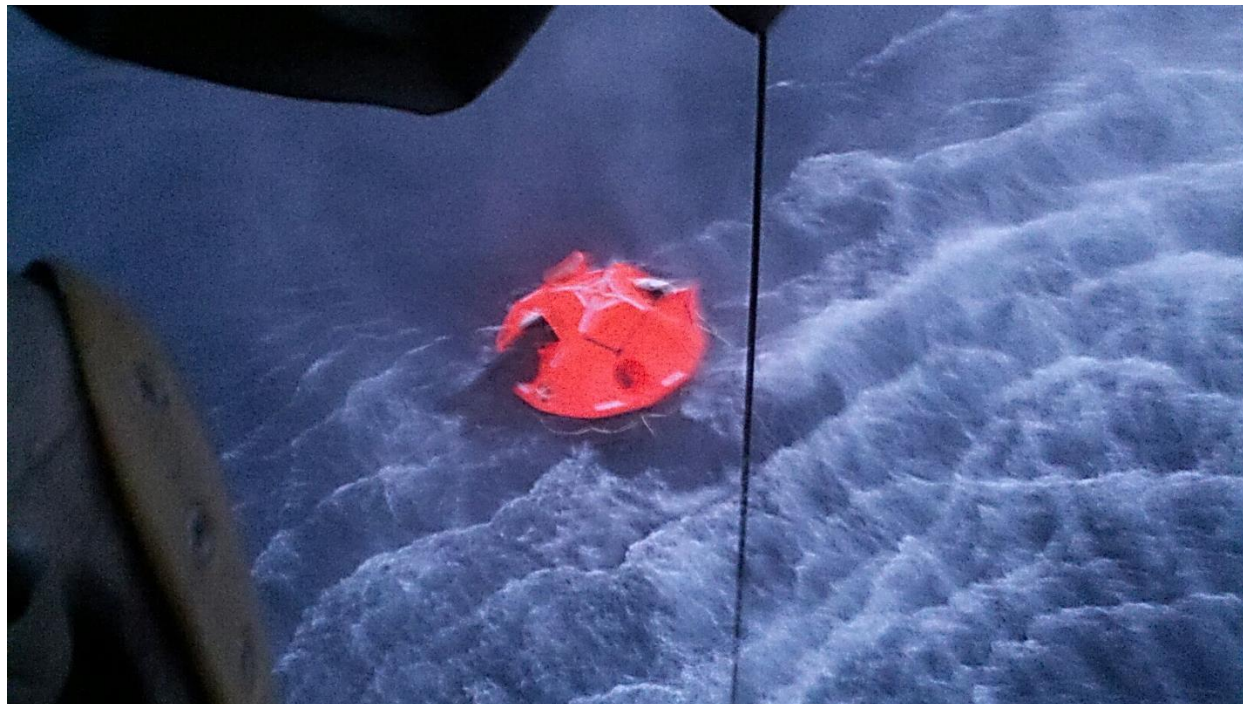
**The inflatable liferaft from which the three *Allison C* crewmembers were hoisted. A California National Guard rescue swimmer can be seen near the liferaft's entrance. (Photo by Tech. Sgt. Jimmy Ford, California National Guard)**
